# Fair Bluff

**HMDRRI**  
Hurricane Matthew  
Disaster Recovery and  
Resilience Initiative

DOWNTOWN FLOOD RETROFIT **2017 REPORT**

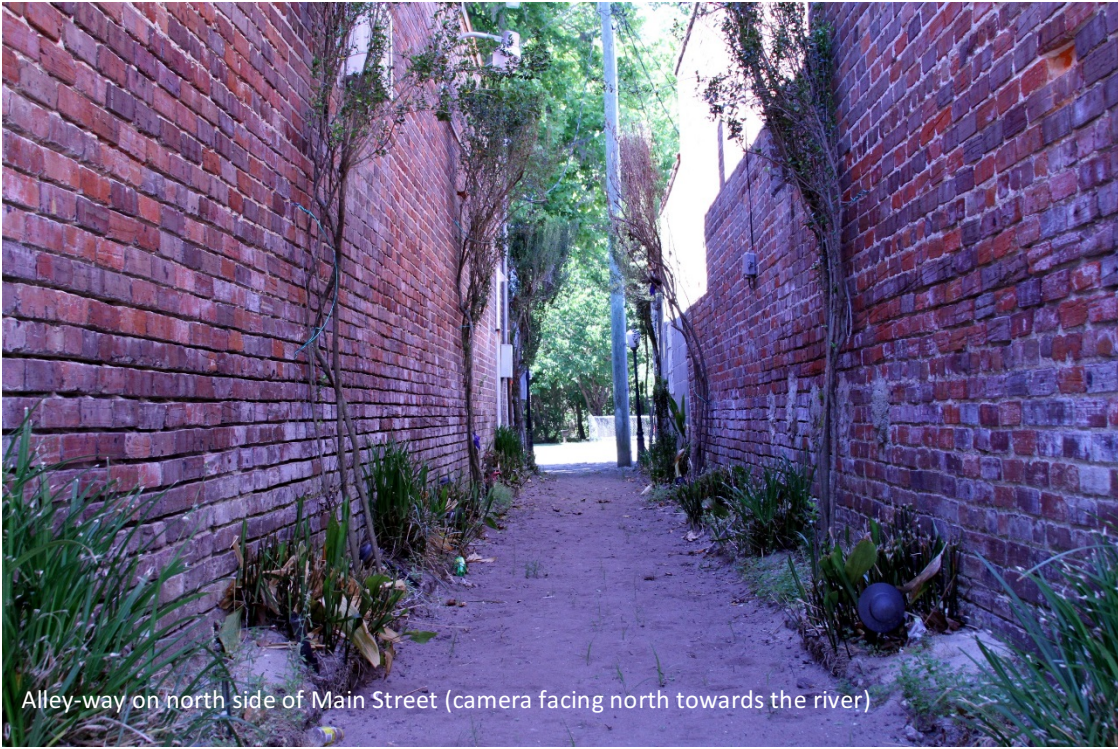
Alley-way on north side of Main Street (camera facing north towards the river)

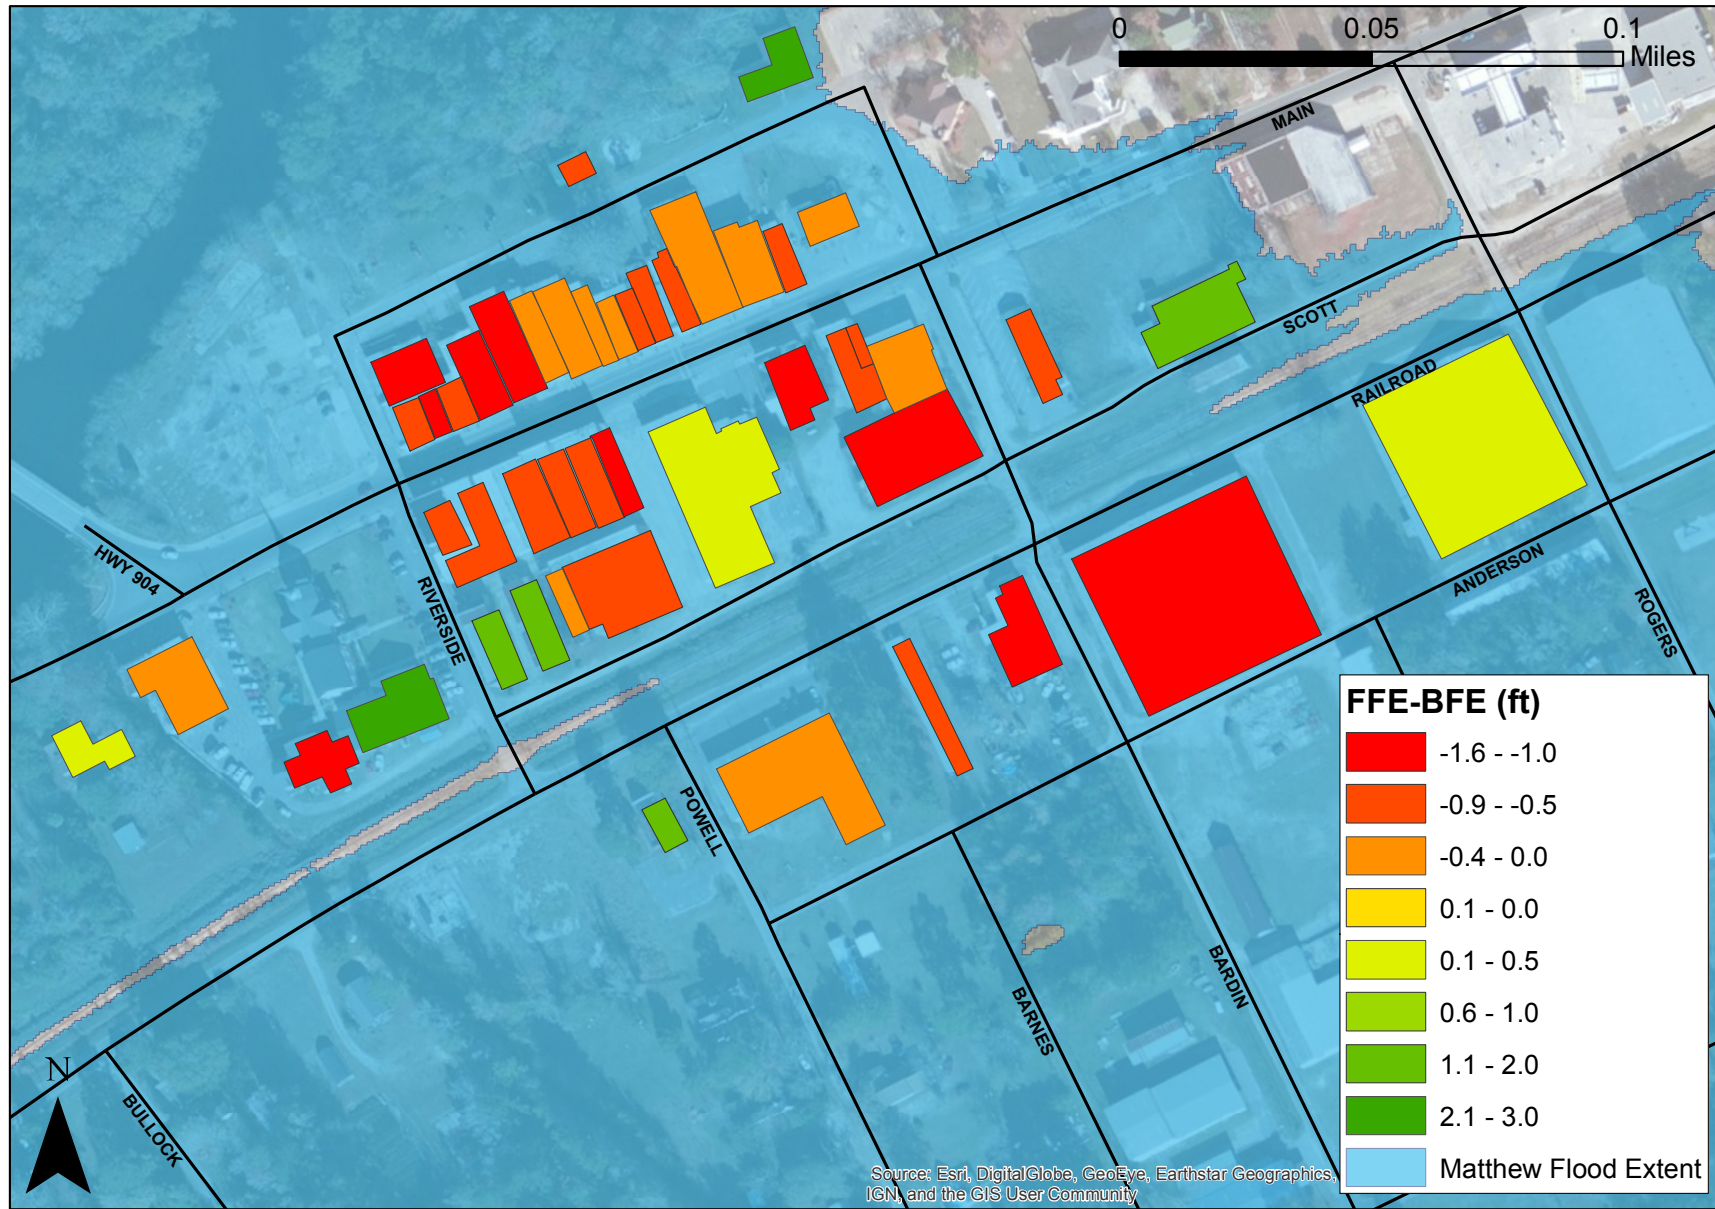
## First Floor Elevation (FFE) - Base Flood Elevation (BFE)

The FFE for Fair Bluff's buildings ranges from about 64 to 69 feet. The negative values in the map to the left indicate insufficient FFE heights compared to the BFE.

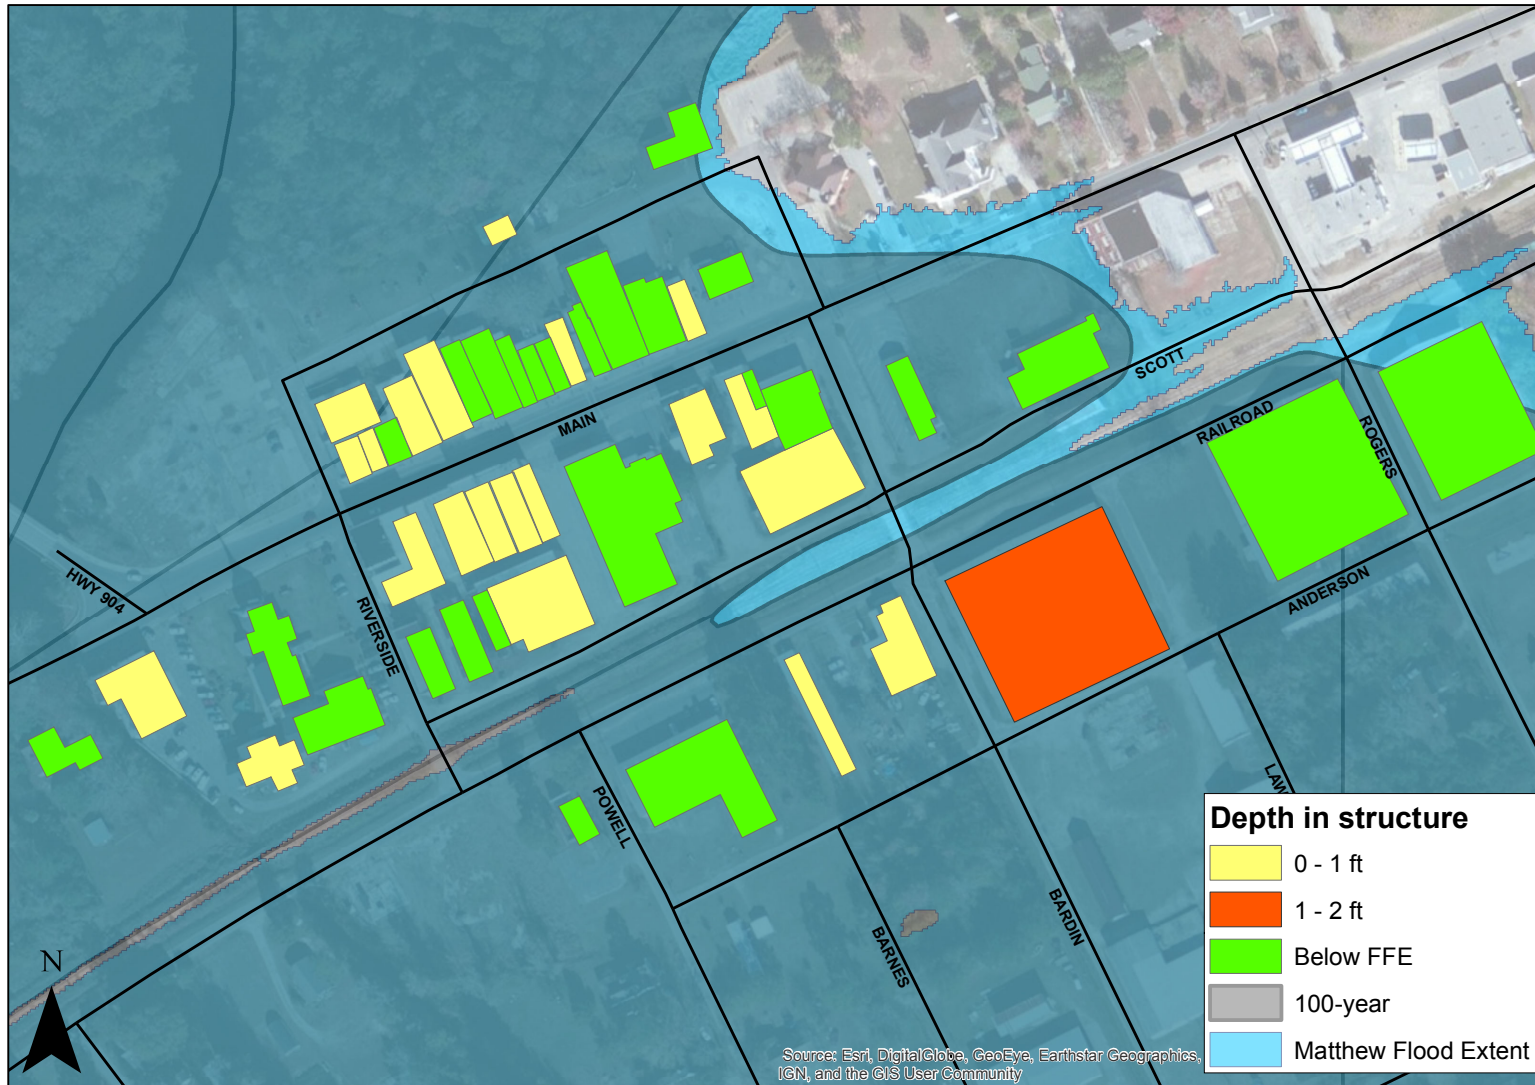
# Downtown Fair Bluff, NC Water Depth in Structure

The maps depicting FFE, BFE, and flood depth illustrate which structures are most at risk to flooding due to their not adhering to BFE requirements. The buildings that experienced flooding had FFEs below the BFE and most of them were built prior to Fair Bluff's FIRMs.

In the map to the left, according to the data, the only building that flooded more than 1 foot is the roofing company that also sustained the most damages.
