HMDRRI
Hurricane Matthew
Disaster Recovery and
Resilience Initiative

DOWNTOWN FLOOD RETROFIT **2017 REPORT**

REID THOMAS – Windsor notes

Windsor Flood Retrofit Study

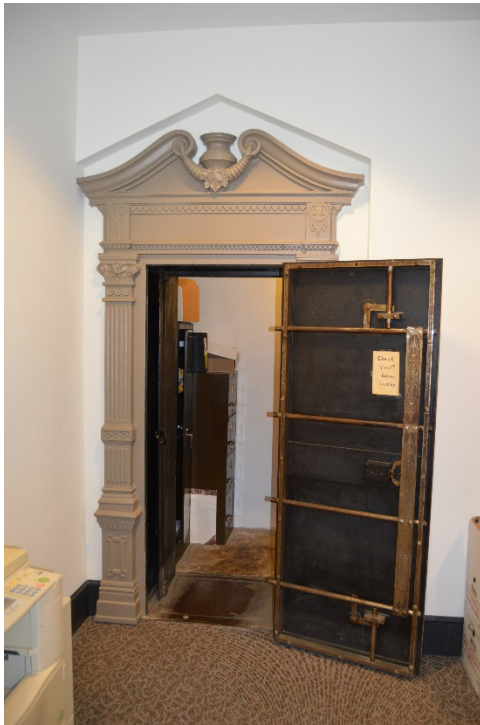
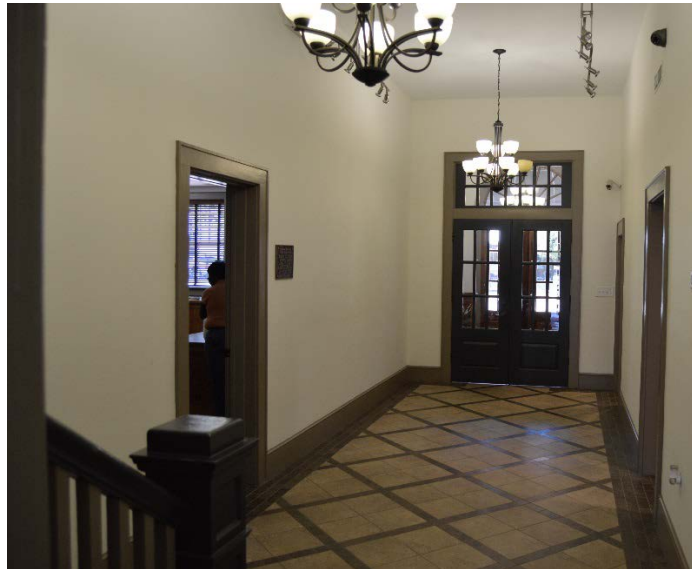
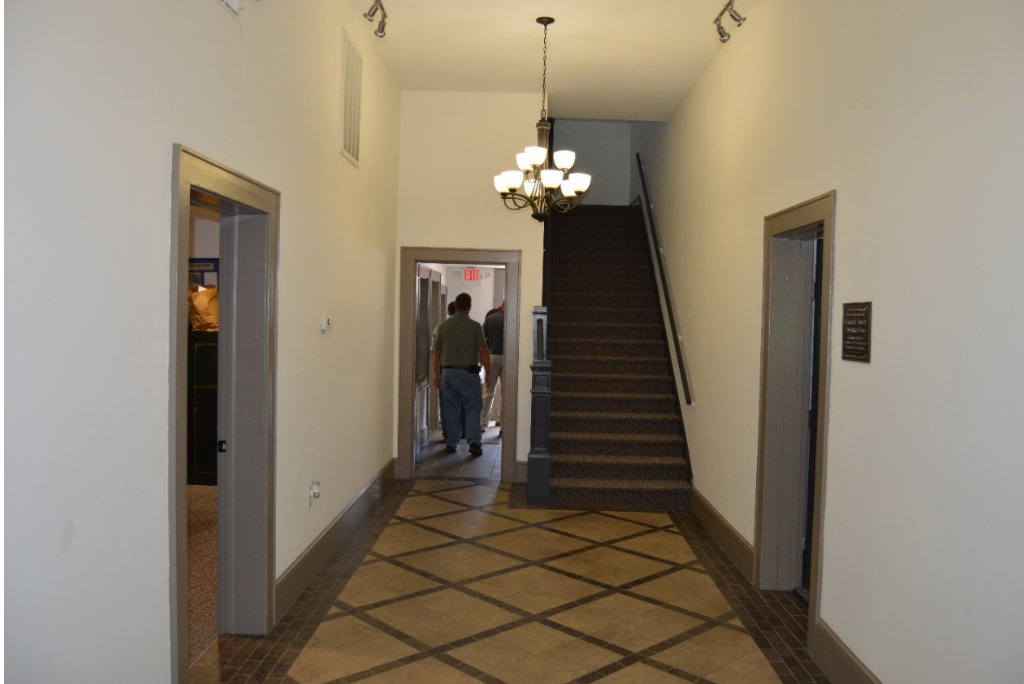
Figs 1, 2, &3. Vault and entry of Municipal Building

Field Notes: The only significant alteration to the municipal building since the National Register nomination was the replacement of the wood flooring with concrete – in 2012. The building retains important character defining features such as the original interior staircase, vault with decorative cast-iron entryway, interior woodwork, historic windows and doors (Figs. 1, 2, & 3).

It would be difficult to raise the floor without impacting the integrity of historic features on the interior.

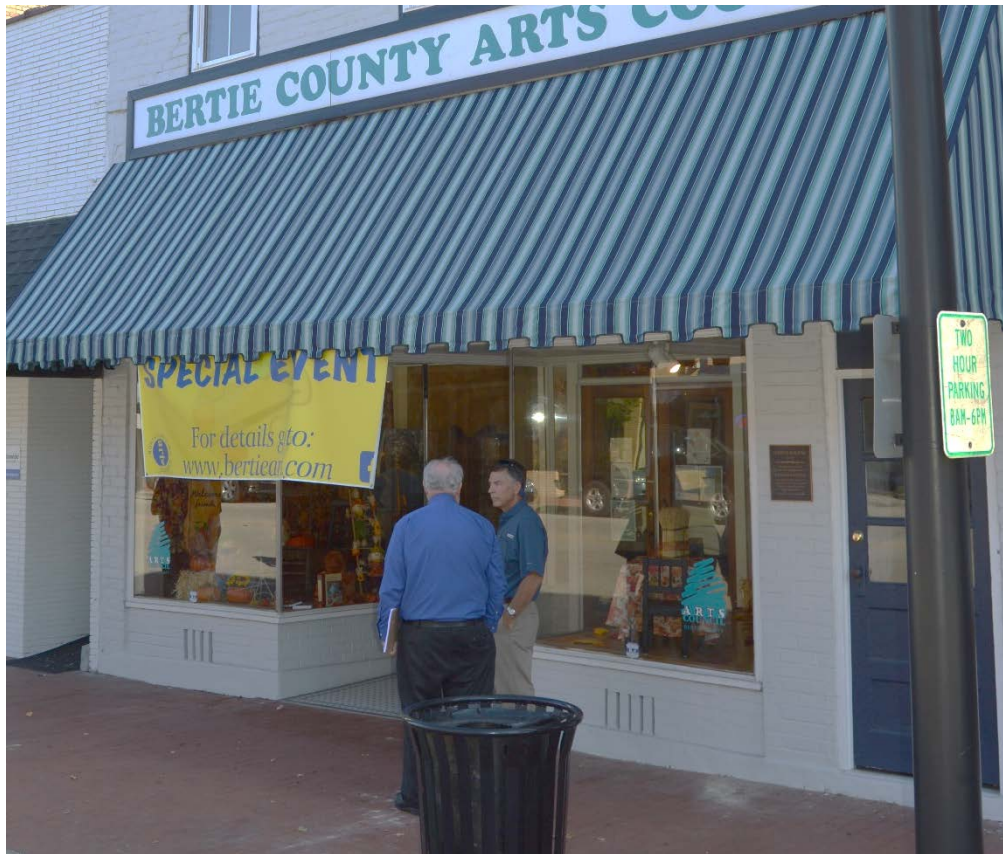
Fig. 4. 124 S. King St.

Upper level is intact with three segmental-arch bays and elaborately corbeled brick cornice. The first floor retains portions of a pressed tin ceiling. In 1924 this building housed the Windsor post office and telephone exchange.

Field Notes: Crawlspace and original wood floor. Discussion on elevating 1st floor. The ceiling height appears to be tall enough to raise the floor level. The random-width original flooring should be preserved if the floor is raised. The existing historic storefront (fig. 4) is an important character-defining element and should also be retained if the interior floor level is raised.

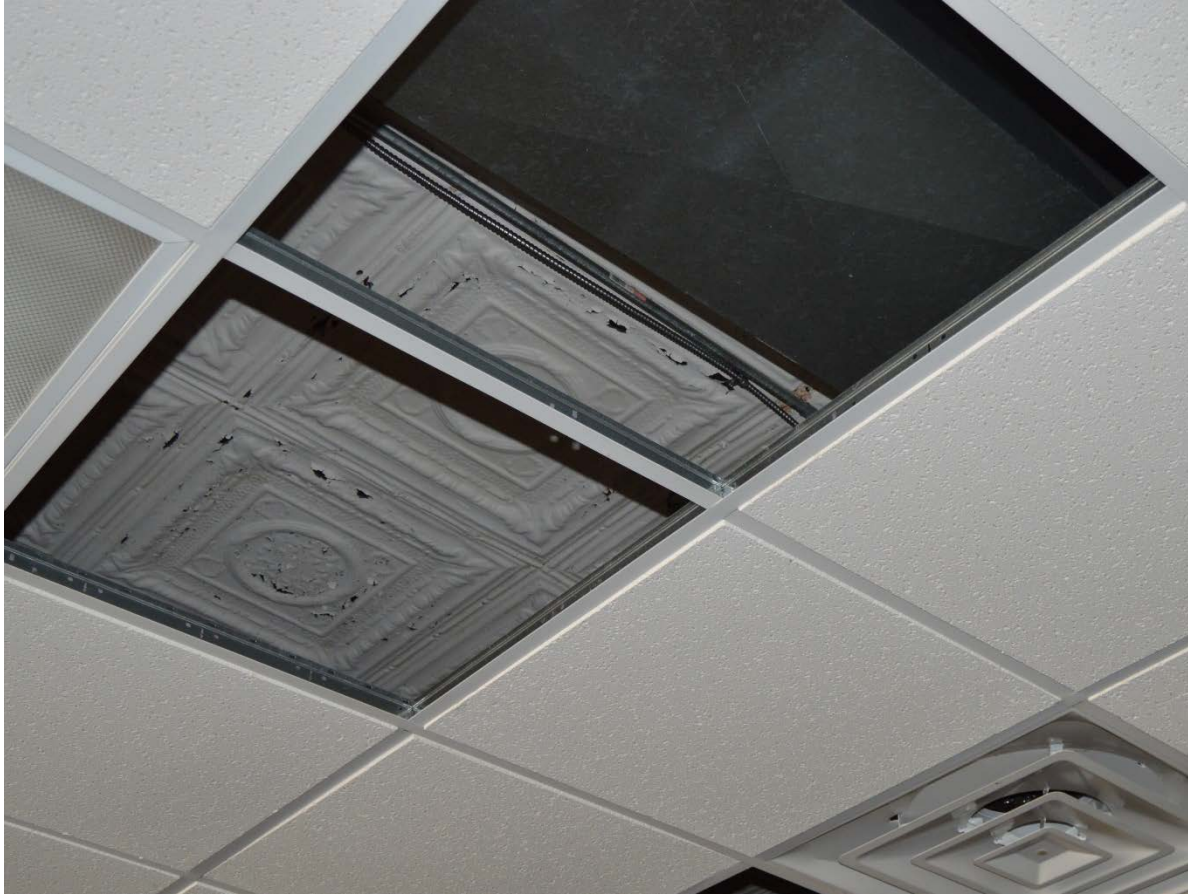
Fig. 5. 112 S. King St.

Early twentieth century two-bay, two-story, brick commercial building with ca. 1950 replacement facade with plate glass display windows, recessed entrance, and metal awning. The building retains portions of an original pressed tin ceiling on the first floor and narrow beaded tongue and groove ceiling on the second floor.

Field Notes: Press tin ceiling can be seen above the dropped ceiling panels (fig. 5). There is a possibility that if the Windsor National Register Historic District is re-evaluated and period of significance is updated this building might be a contributing resource – eligible for historic tax credits.

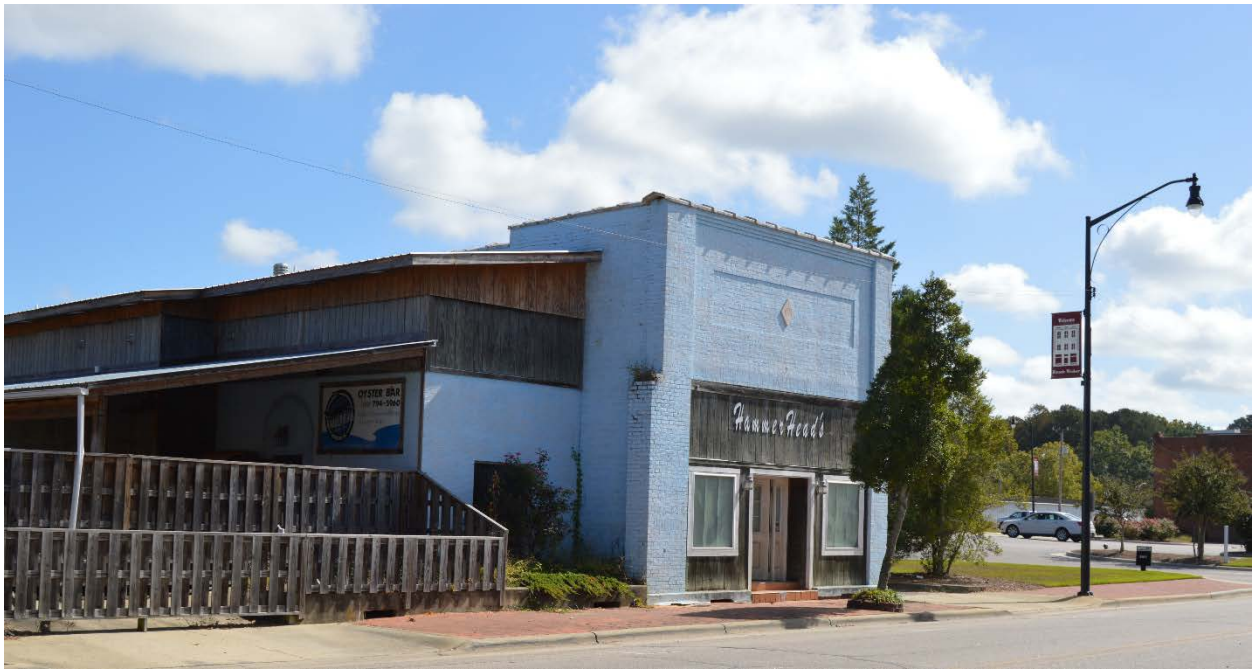
Fig. 6. 117 North King St.

Small one-story brick structure with large recessed bay which has received ca. 1978 infill of paneling and a large multipaned window; 1929 dated concrete or stone diamond shaped plaque on 2nd story facade wall.

Field Notes: Press tin ceiling survives approximately 8 feet above dropped ceiling. Told it was used as a post office. Potential for rehabilitation and use of the historic tax credits. Stabilize and mothball if possible for future use. Non-historic lean-to addition added to west side (fig. 6)
