Seven Springs

HMDRRI
Hurricane Matthew
Disaster Recovery and
Resilience Initiative

DOWNTOWN FLOOD RETROFIT **2017 REPORT**

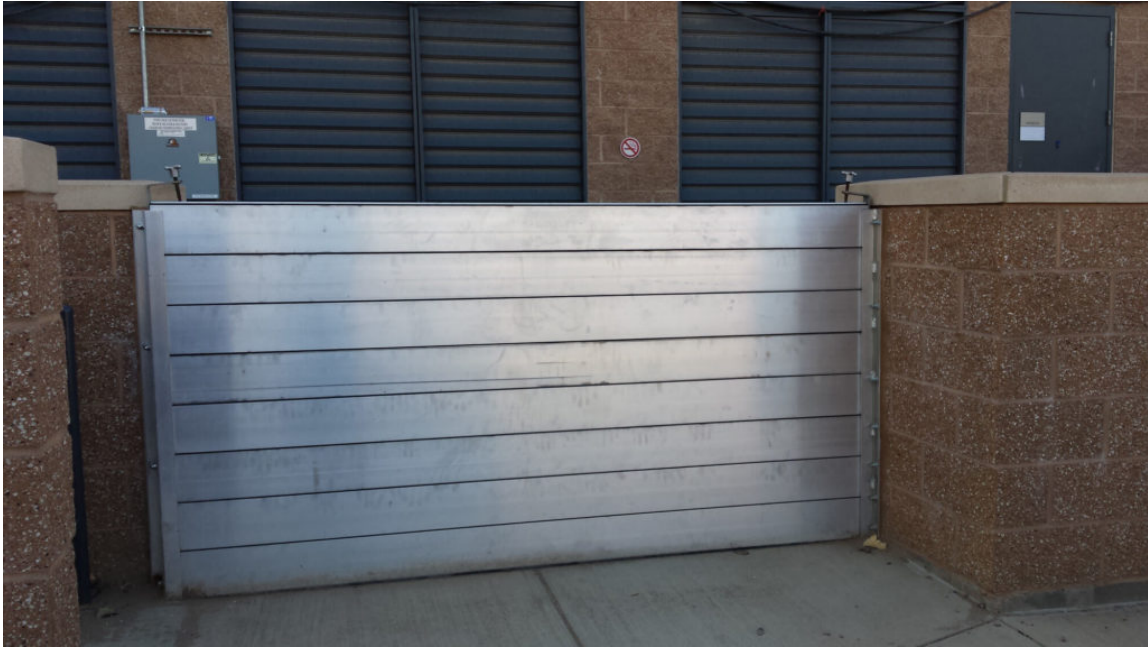
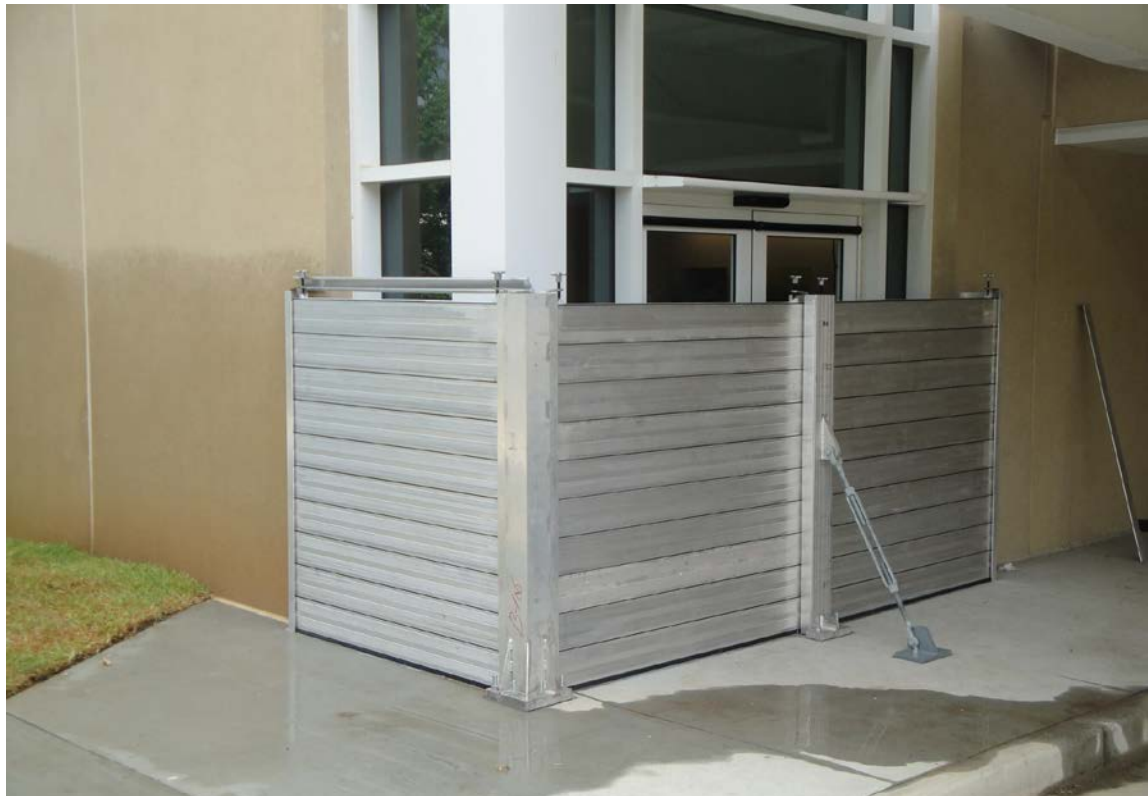
Dry Floodproofing Examples

Below are two examples of dry floodproofing methods.

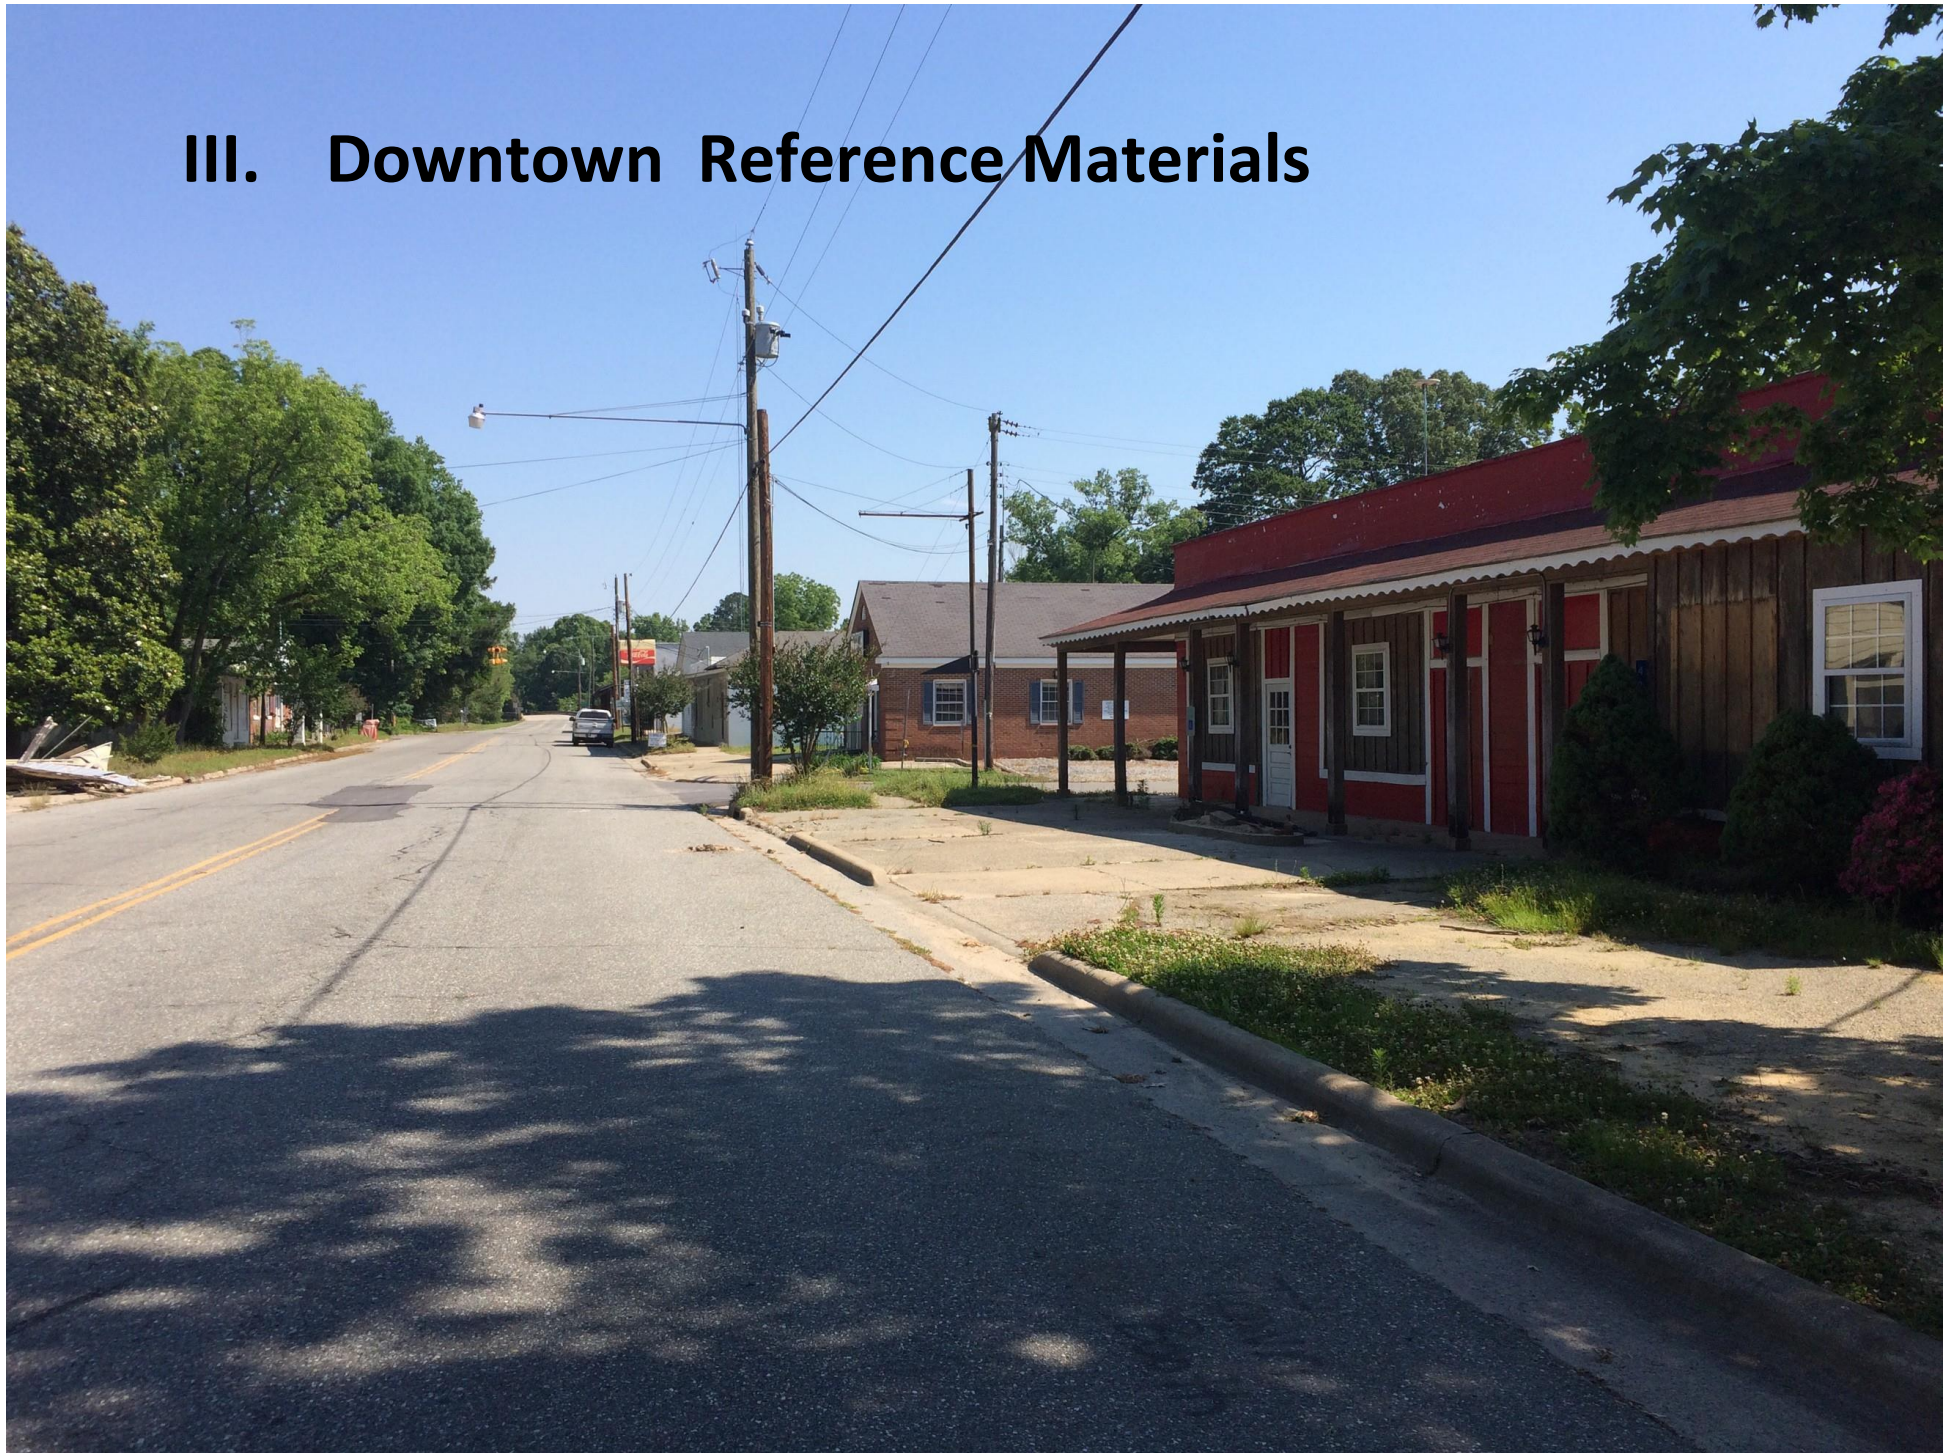
Seven Springs, NC Buildings and Preliminary Extent of Hurricane Matthew

Seven Springs is a town of about 100 people and their historic downtown dating back to the civil war was completely flooded in Hurricane Matthew. The map above shows the historic district and town boundaries as well as notes all non-residential structures.

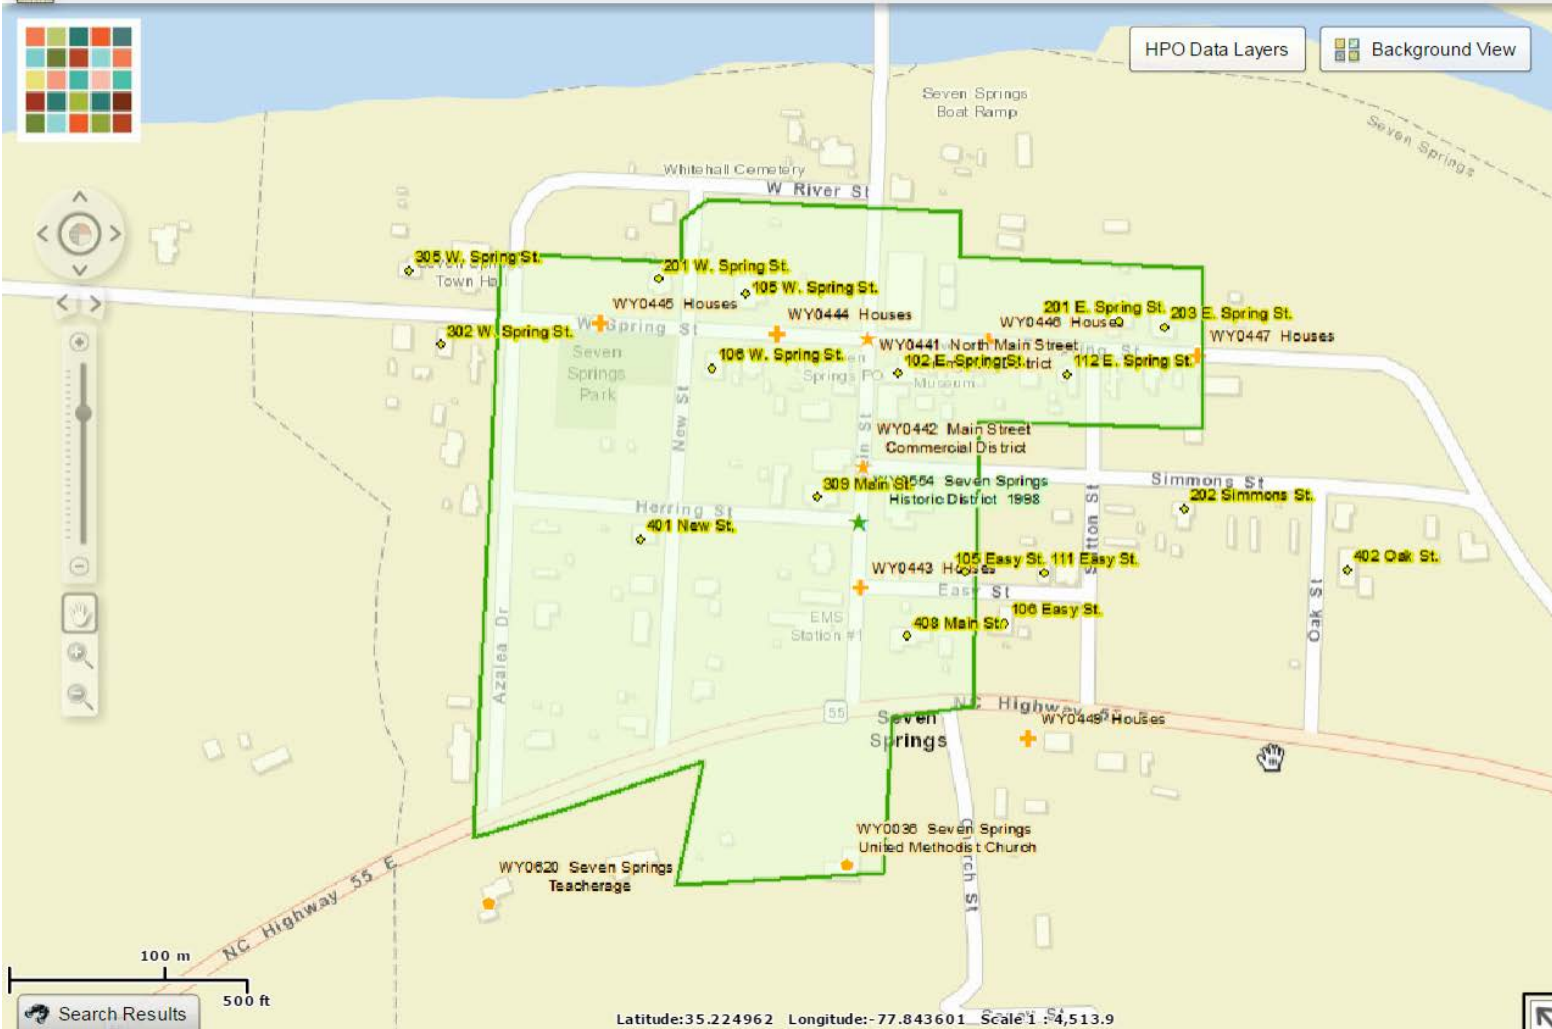
I am attaching a screen shot from our internal GIS that shows the boundaries of the historic district that we determined eligible for listing in the National Register of Historic Places as a result of planned hazard mitigation projects by FEMA through Wayne County.
